# Investigations of the core column issue in ATLAS ITk pixel modules

Craig Buttar

On behalf of the ATLAS ITk Collaboration

HSTD14

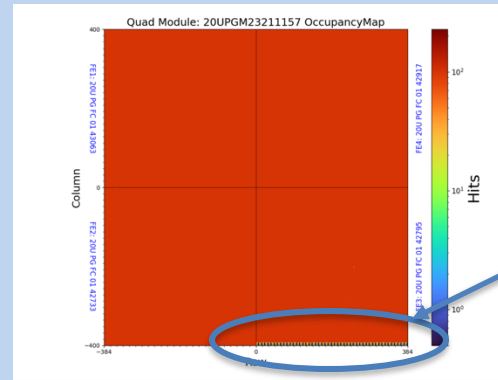
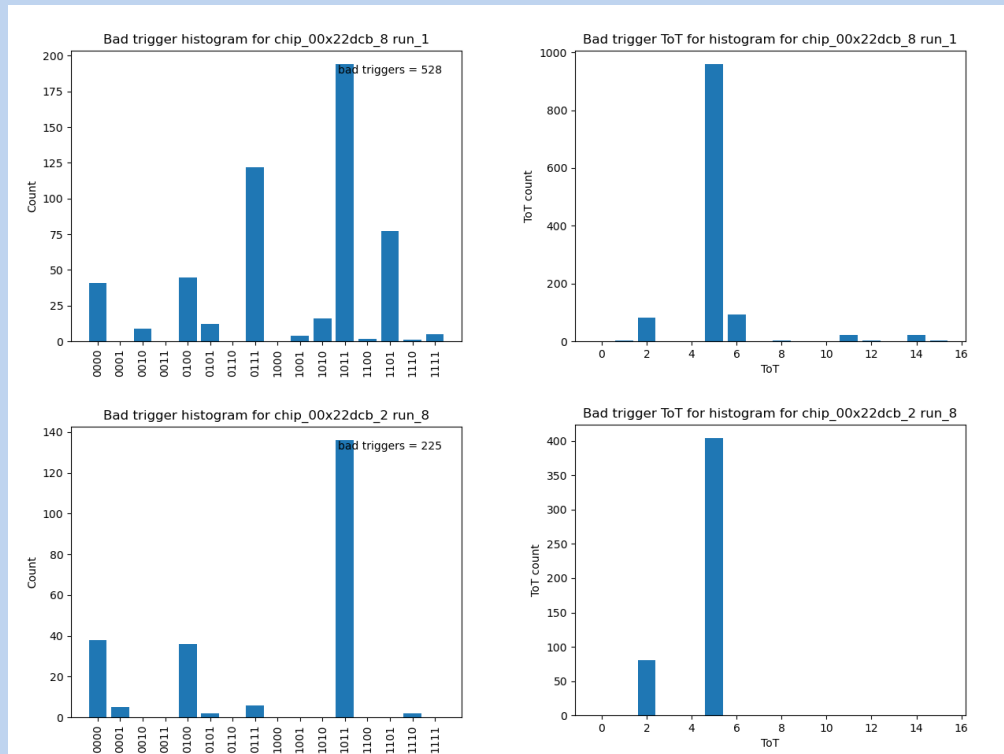
## An example of core column issue

- Normally core column locks the chip but look at special cases to try and understand underlying behaviour
- This chip exhibits defective core column behaviour but does not lock the chip
- Core column disabled
  - Chip 3 CC 1 (columns 1-8)
- Digital scan
  - Injecting directing to digital part of chip
  - ToT=5
  - Trigger bin=1000
- Look at number of out of time hits ie not in the specified trigger bin (1000) and their ToT
- Results were not repeatable over 8 runs
- Similar behaviour seen in other modules with bad core columns
- Cross-check with good chip, no bad triggers and ToT=5 for all pixels

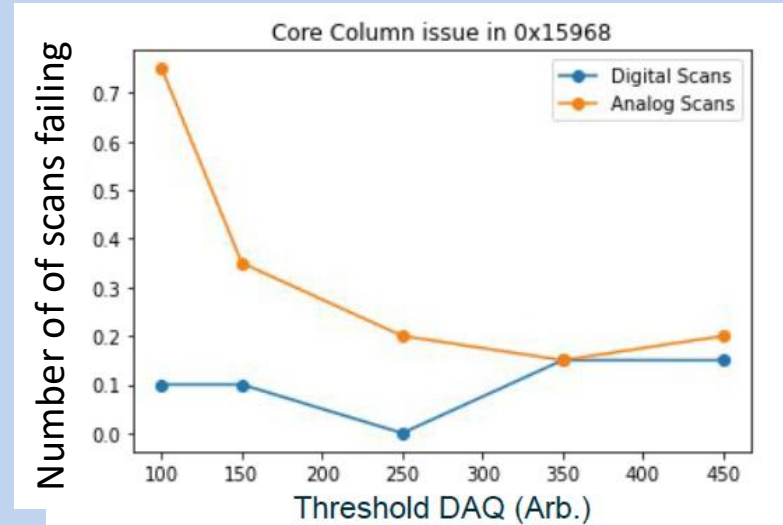
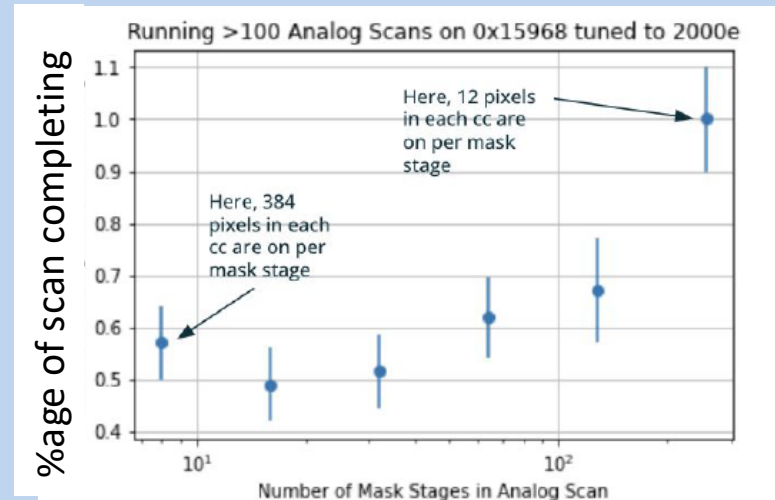
- Core columns with issues can show up in later scans eg threshold scan
- Digital scan shows no core column issue but at low threshold, increasing number of core columns in analog scans
- Increasing number of core columns for increasing number of pixels/mask step
  - Typical value is 384 pixels/mask step

Pixel scan = #mask steps X #pixels/mask step

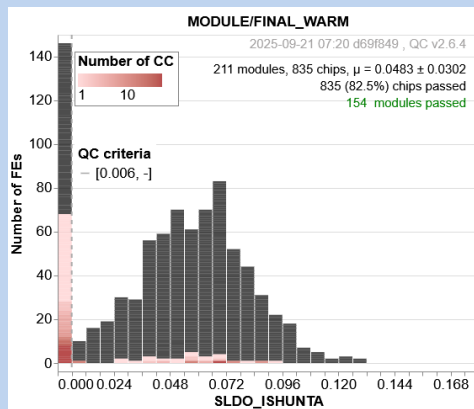
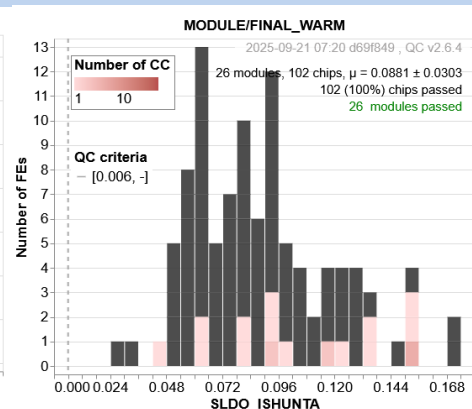
- Core column issues in vendor B modules are often accompanied by sLDO failure (typically shunt current is zero). This correlation is only observed for vendor C

## Vendor B modules

## Vendor C modules

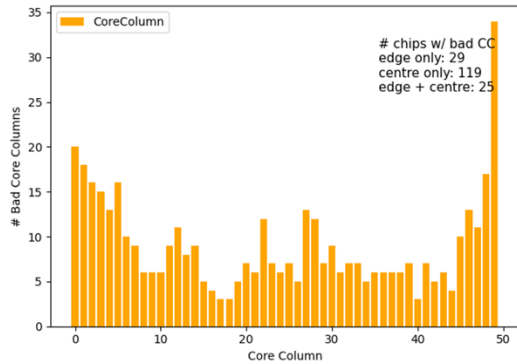
Core column position vendor B

- Vendors show a different distribution of core columns across the pixel matrix
- Substantial variation of number of bad core columns with wafer at both vendors
- Vendor A has a very low number of bad core columns not discussed further

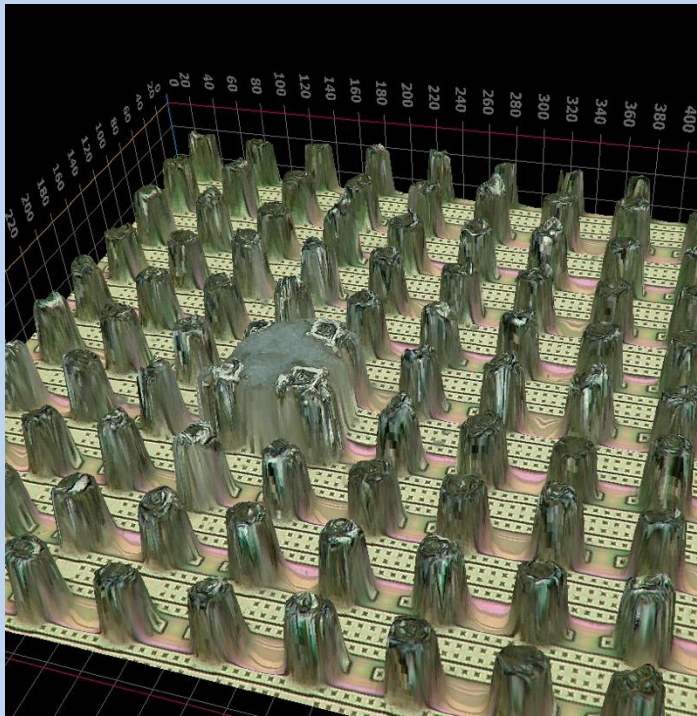
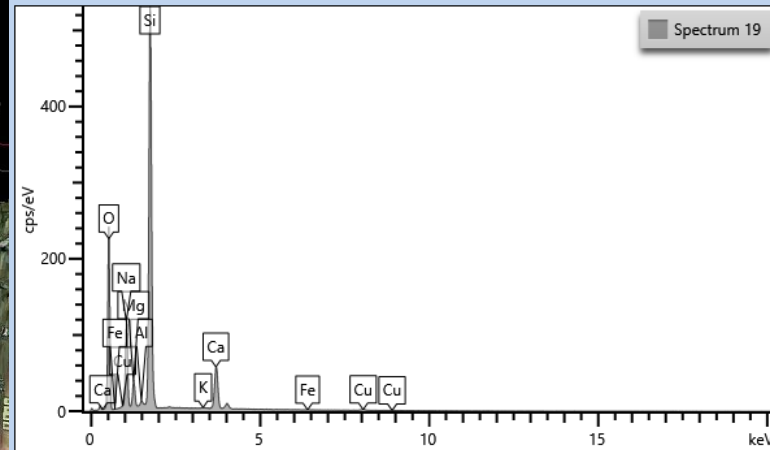
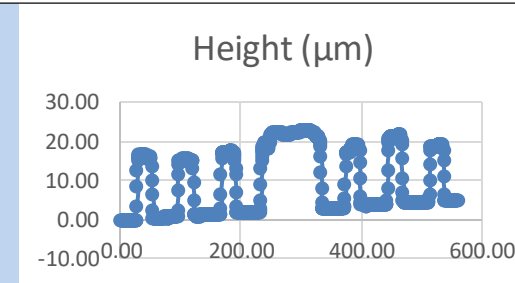
- Pull module apart and look at pixel matrix
- Large lump of silicon (EDX) embedded in the matrix and position of disabled core column
  - height corresponds to flip-chip height
- Other defects observed but not associated with disabled core columns and their height is lower than flip-chip height
- One other module pulled part and showed similar results

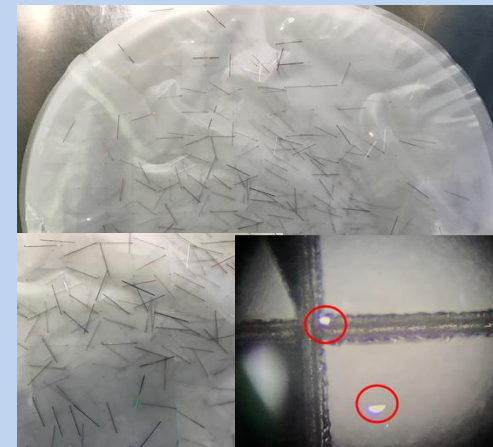
Double dicing removes test structures but leaves Si dust

- Defective core columns appear to be caused mainly by debris across the surface. Aim to reduce debris on surface
- Current FE-wafer bump deposition vendor
  - Improved handling after dicing by replacing dicing tape
  - Rate of modules with defective core columns reduced from 39% → 20%
- Use the same FE-wafer bump deposition vendor and dicing vendor as vendor A
  - Rate of modules with defective core columns reduced from 39% → 20%
- Improvements have also significantly reduced the number of sLDO failures associated with core column issues
  - 72% → ~27%

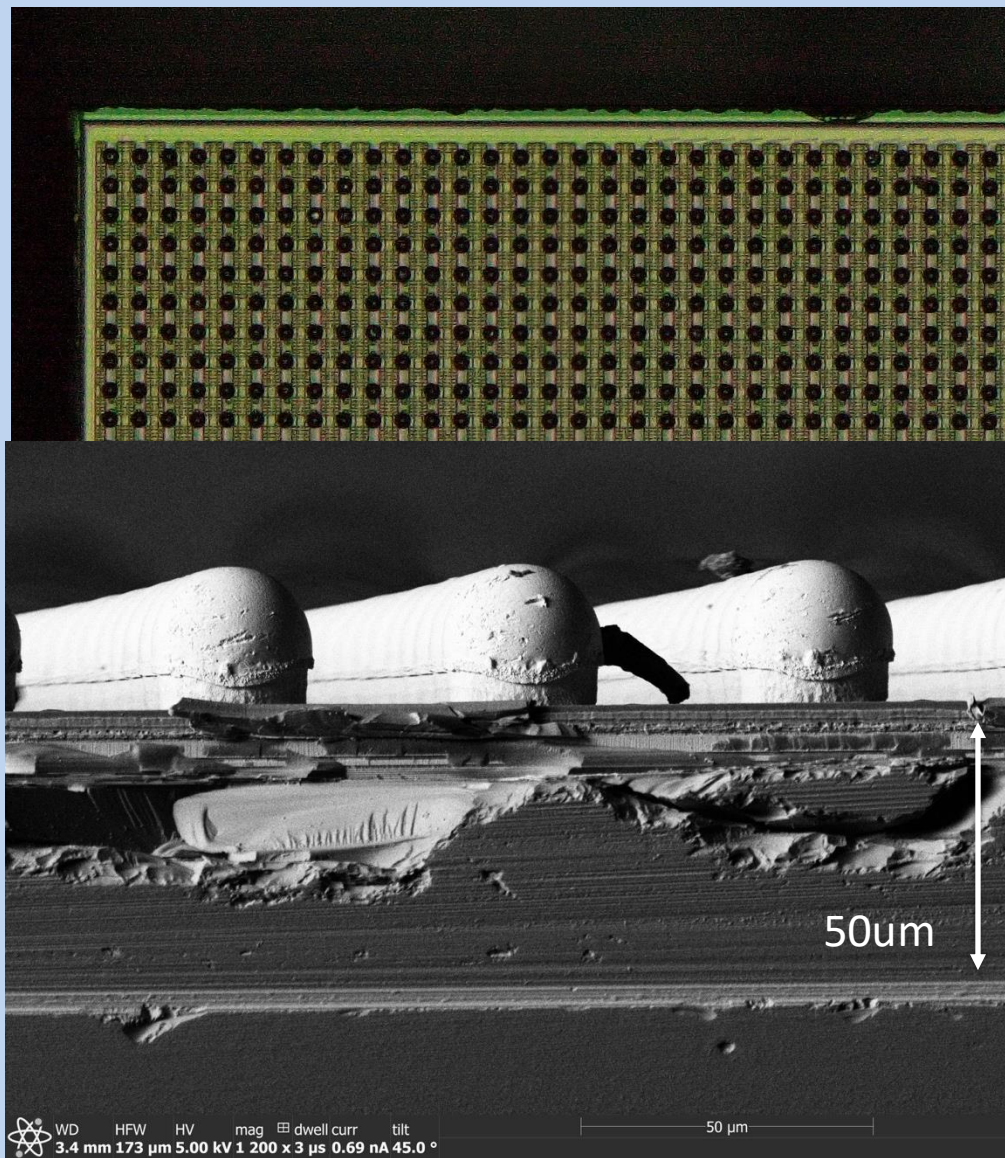
- Defective core columns appear to be caused mainly by edge chipping
- Chipping on edges shows significant damage near the surface of the chip
  - Attributed to low-k dielectrics used in 65nm CMOS process being difficult to saw
- Can result in damage up to the seal ring or into the matrix and debris on the matrix

- Use laser pre-grooving to reduce damage at the edges when cutting low-k dielectric
- Initial studies show less chipping at edges
- Modules currently being assembled for electrical tests
