# Status Report

# Noise Test - 1st

# Noise Test – 2nd

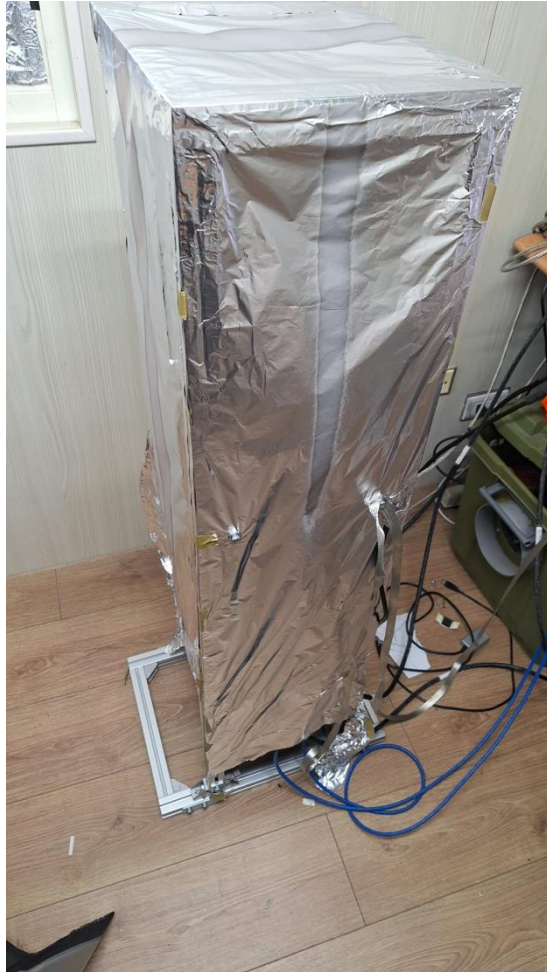
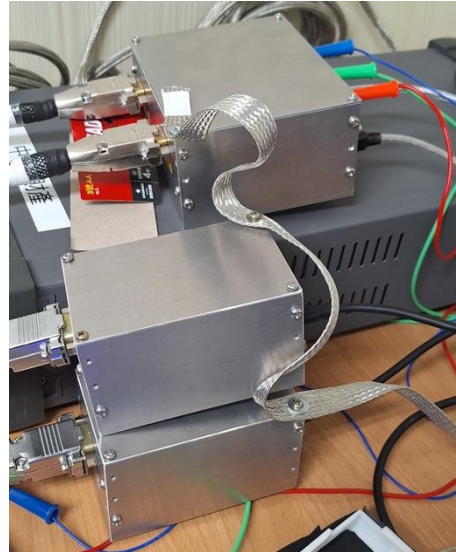
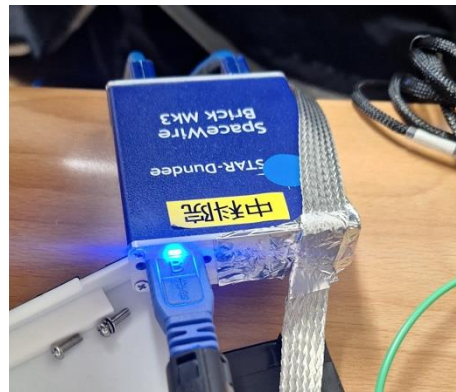
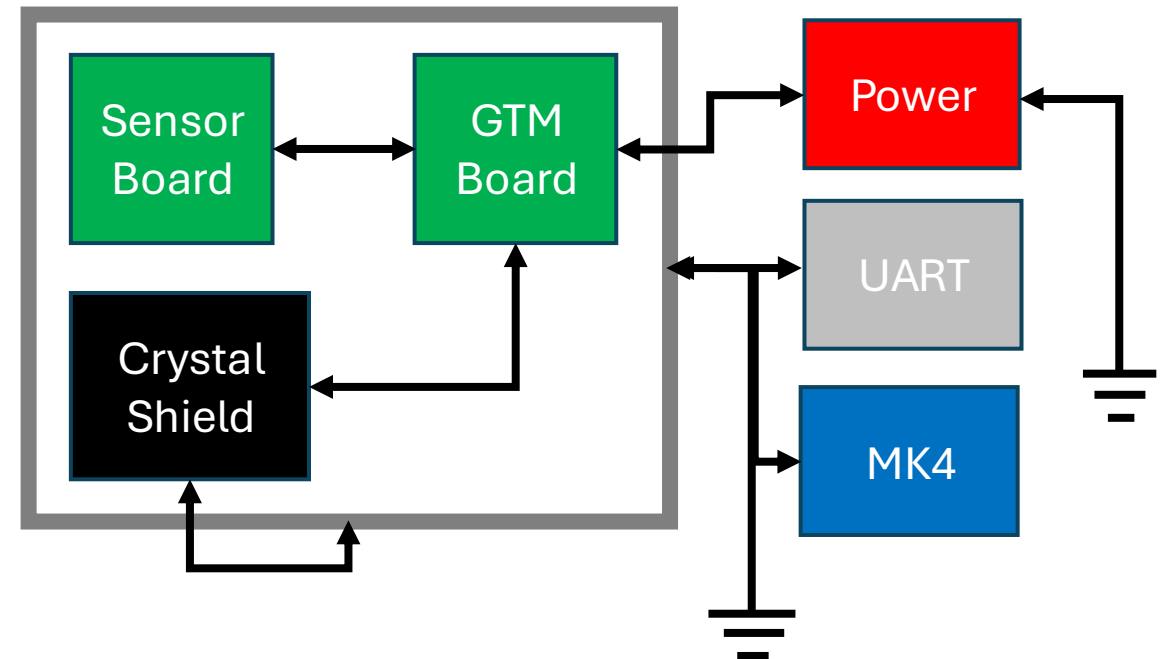
- Use the aluminum foil to cover the Al extr. Frame.
- Use the wire to connect the GTM and crystal shield.
- Use braided sleeving to connect the frame, UART and MK4.

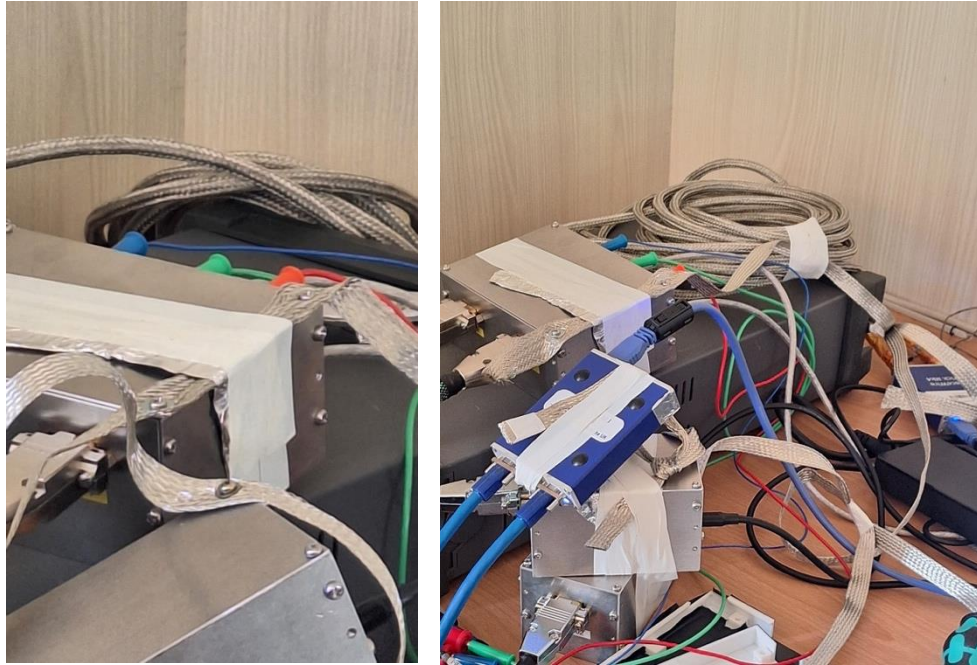
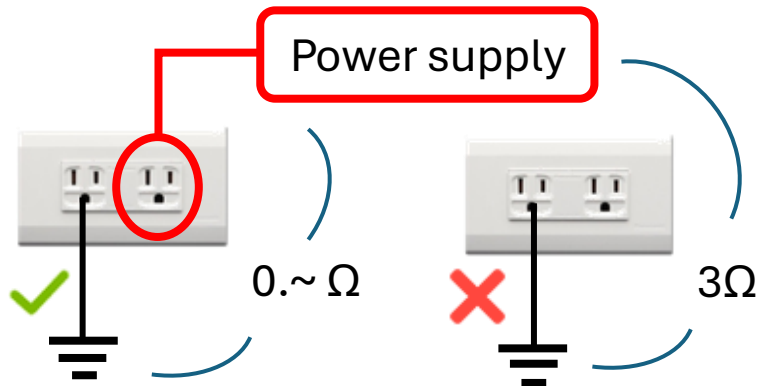
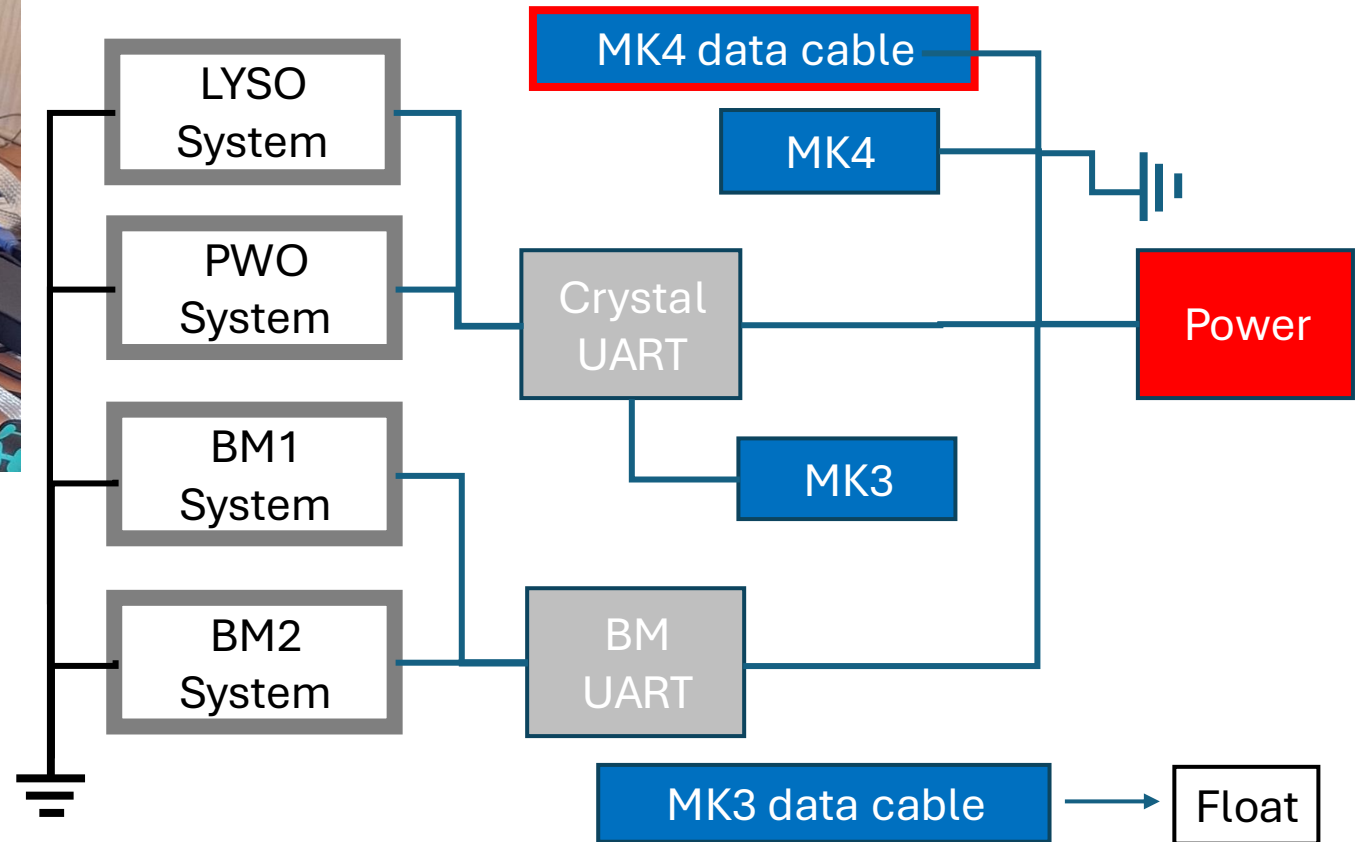
- LYSO was turned off.
- The MK4 shielding wire will let the signal not stable.
- UART needs to be surrounded by a grounding wire.

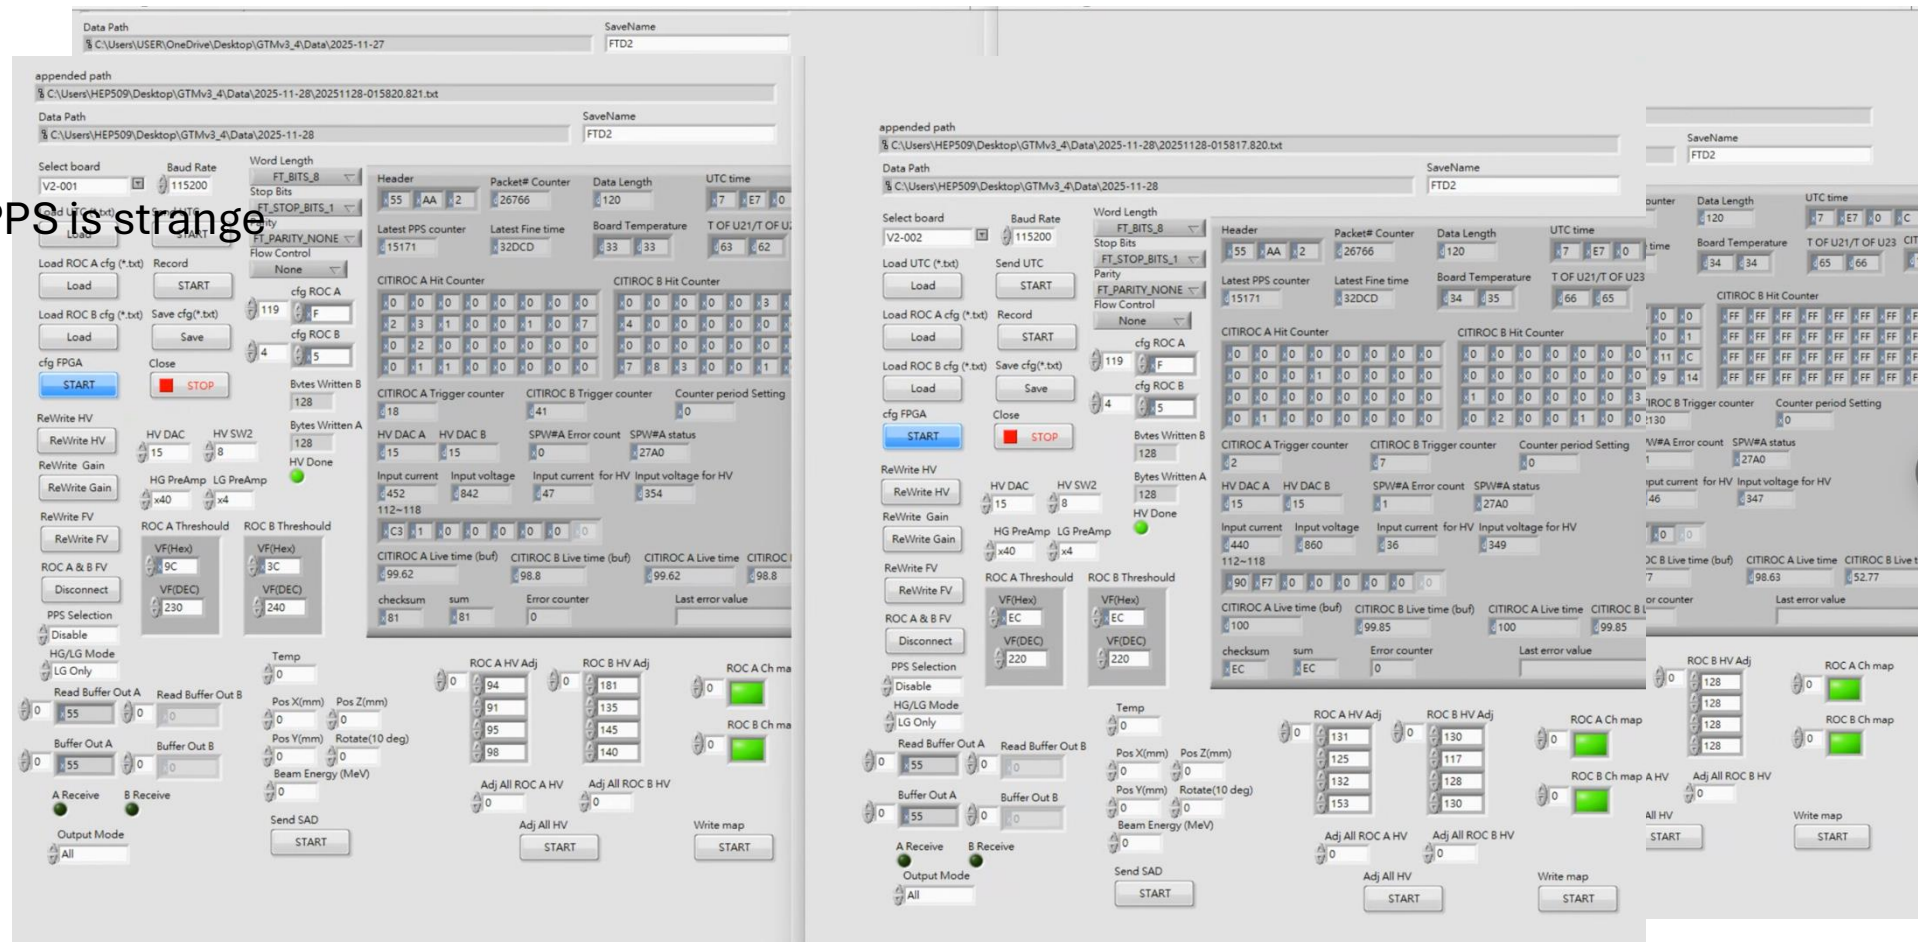
LYSO PPS is strange

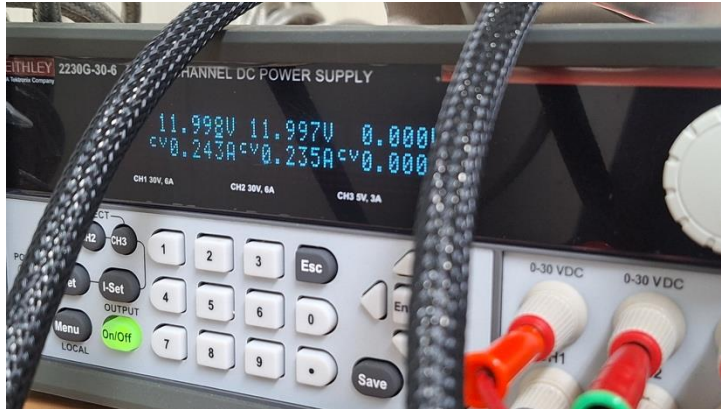
No HV:

- Power outage occur in NCU at AM 3:00
- The CitiROC is normal
