# Evaluation of quality control (QC) of ATLAS18 production ITk strip sensors

**The 14th international "Hiroshima" Symposium on the Development and Application of Semiconductor Tracking Detectors**

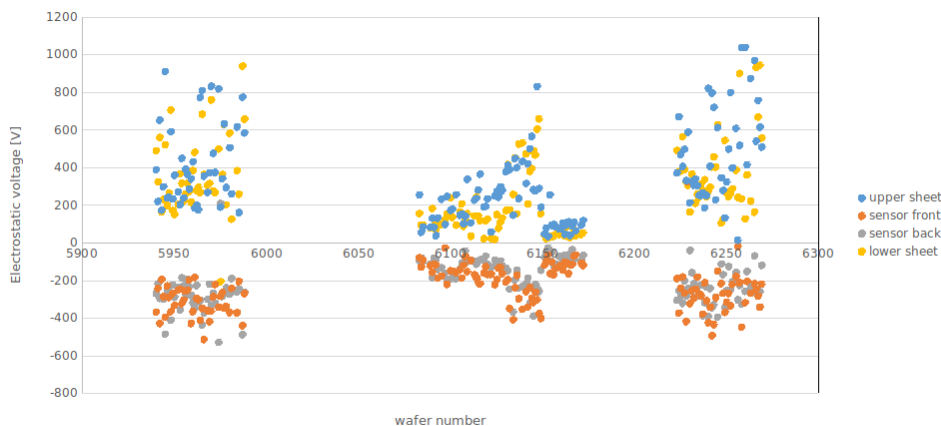
UV treatment

- Strong correlation with high static charge measured on sensors and electric tests failures.
- A big part of failed sensors can be recovered with different treatments [1,2]:
  - 1) **UV-A** (315-400 nm) light setups with typical exposure between 2 and 8 hours,
  - 2) **UV-C** (100-280 nm) light setups with typical exposure of 60 seconds,
  - 3) **ionizing air blowers** with typical exposure of a few minutes up to 30 minutes,
  - 4) High-temperature (160 °C) exposure ("**baking**") of sensors in an oven for more than 16 hours.

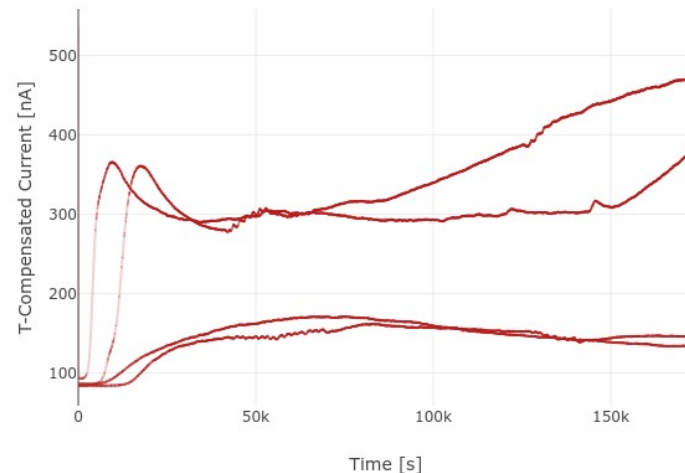
## Stability fail examples

Leakage current variation < 15 %.

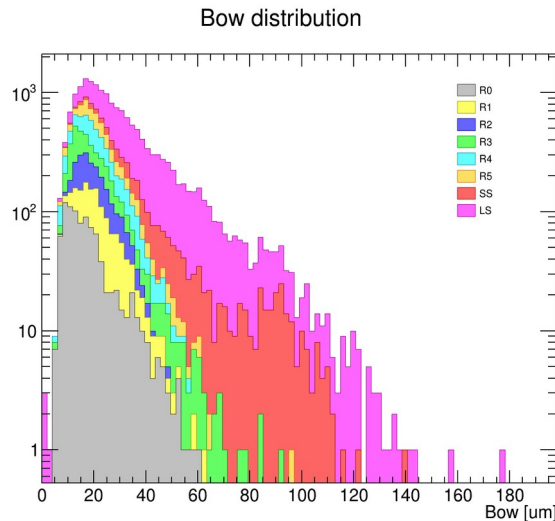
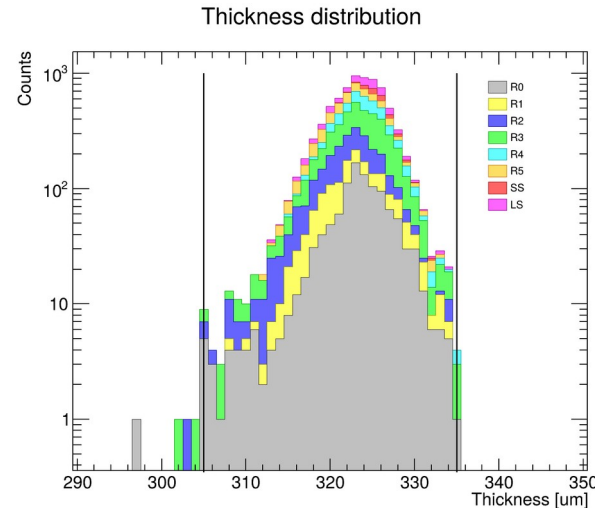
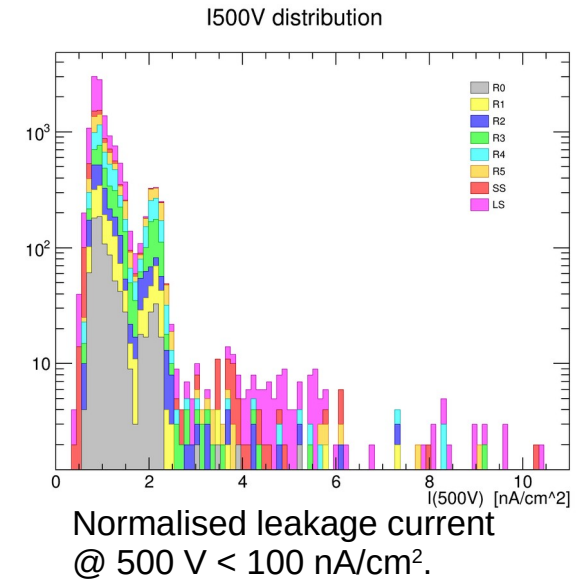
- All sensor types satisfy the specification limit for bow (< 200  $\mu\text{m}$ ).
- The barrel sensors exhibit a slightly broader distribution compared to the endcap types.
- All sensors also comply with the thickness specification; borderline cases were manually accepted considering the measurement accuracy.
- The normalized leakage current at 500 V is well below the specification for all sensor types.

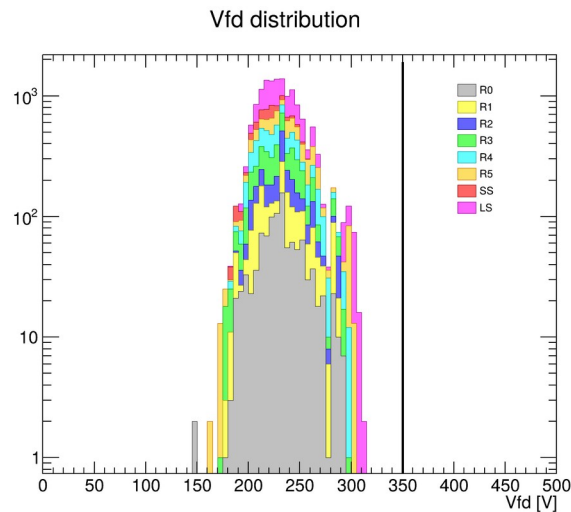
Full depletion voltage < 350 V.

- The distribution of full-depletion voltage (Vfd) indicates that all sensors are well below the specification limit of 350 V.
- From the breakdown voltage distribution, it can be observed that a small fraction of sensors (~ 1%) did not meet the specification, while approximately 99% passed, with a large amount showing no breakdown.
- The leakage current variation also satisfies the specification for the majority of tested sensors (~ 99%).

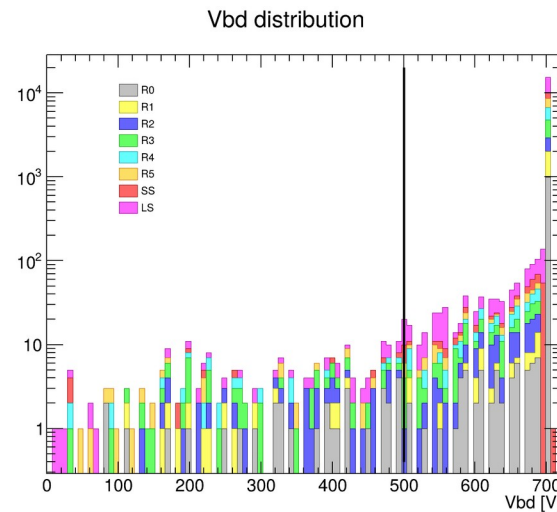
Breakdown voltage > 500 V.  
Sensors in the final bin have  
no breakdown.

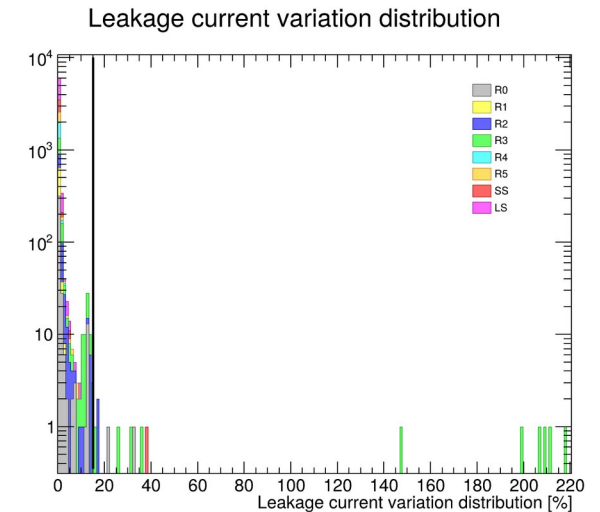
Leakage current variation < 15 %.

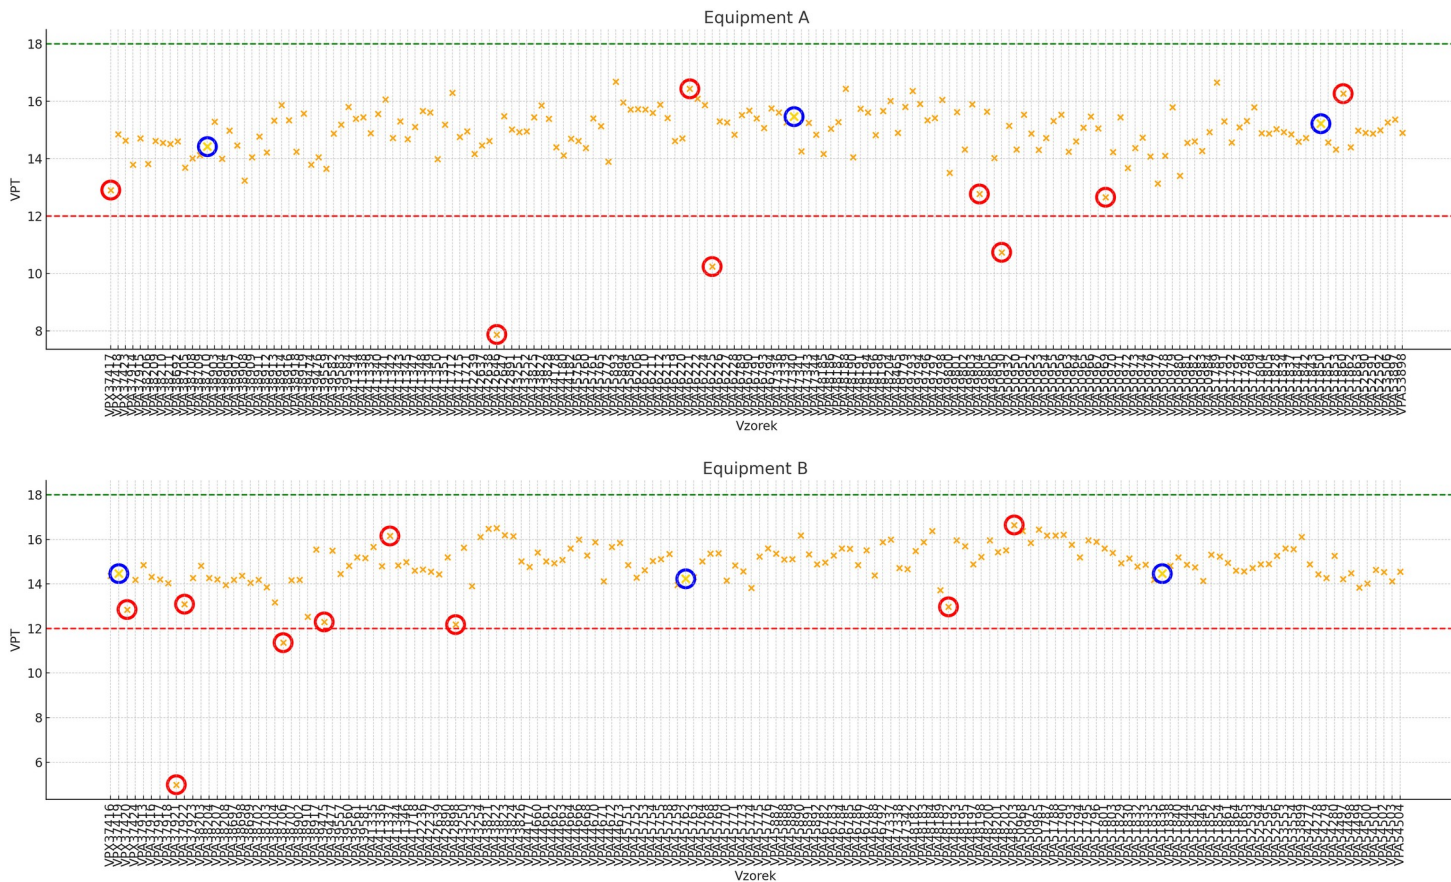
- Interstrip isolation is essential in ITk strip sensors to minimize charge sharing and maintain high spatial resolution by reducing readout noise.
- QA results indicated that the threshold voltage ( $V_{PT}$ ) of the Punch-Through structure (PTP) is out-of-limit in several production batches.
- (see [Quality Assurance during production of the ATLAS18 ITk strip sensors – R. Orr](#))
- To verify whether  $V_{PT}$  is non-uniform across a wafer or else, PTP measurements were performed on main sensors from the affected batches.
- For comparison, additional PTP measurements were performed on main sensors that either satisfied the QA specifications or were close to the specification limits ( $12\text{ V} < \text{PTP}_{IV} < 18\text{ V}$ ), for two different furnace processes.

The acceptance limit for PTP correspond approx. 4-times the standard deviation.

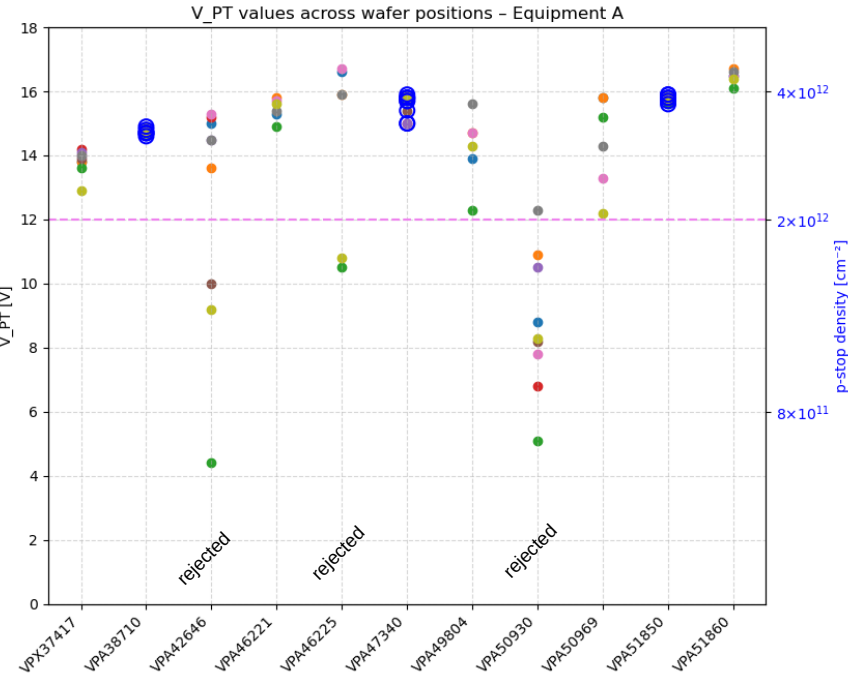
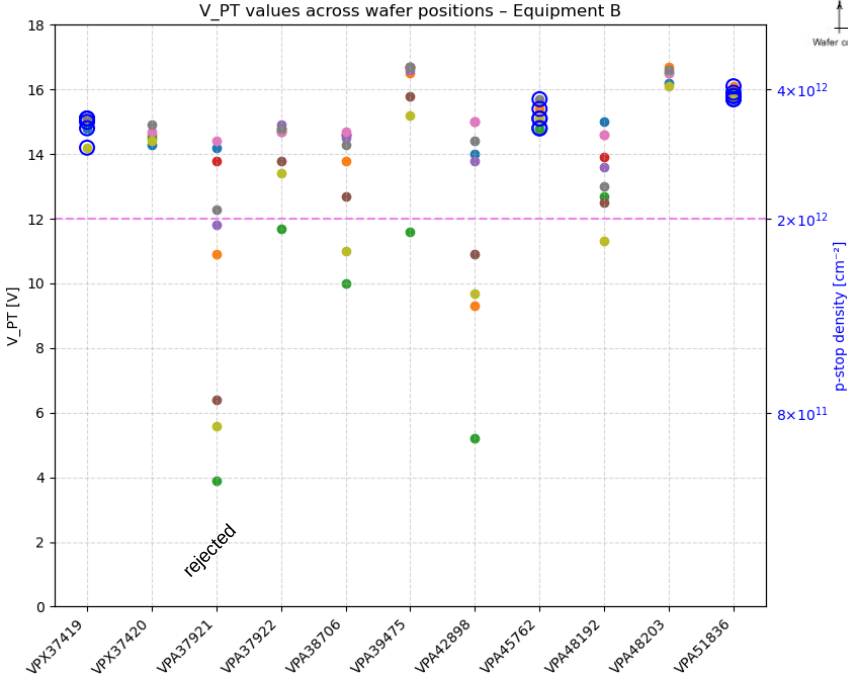
- The punch-through voltage ( $V_{PT}$ ) in the affected batches decreases in some cases from left to right across the sensor (i.e., with increasing strip number), consistent with a reduction in p-stop doping. Towards the right side,  $V_{PT}$  falls below the specification of 12 V.
- Observed results: When the QA results are within specifications, the PTP measurements on the main sensors are satisfactory as well. QA results near the specification limits do not necessarily indicate poor PTP performance on the main sensors. When the QA results deviate significantly from the specifications, the PTP results on the main sensors are also poor.
