# Analysis of unstable leakage current in ATLAS18 Strip Sensors after long-term tests

14<sup>th</sup> International "Hiroshima" Symposium on the Development and Application of Semiconductor Tracking Detectors

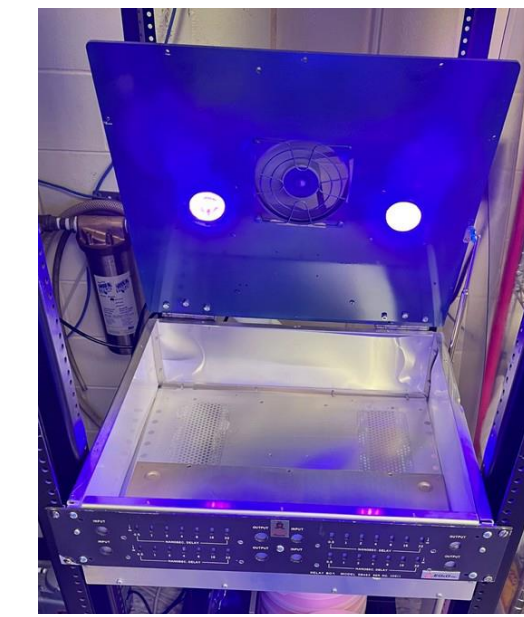
- influence of environmental conditions and long-term testing on ITk Strip Sensors have been studied since the prototyping phase and continued during sensor production
  - among others, surface charge build-up and elevated ambient humidity found to adversely affect sensor performance

- different methods of sensor recovery were developed to mitigate performance changes
  - ionizing guns / ion blowers, UV-A/UV-C irradiation, sensor baking
