# Investigations of the core column issue in ATLAS ITk pixel modules

Craig Buttar

On behalf of the ATLAS ITk Collaboration

HSTD14

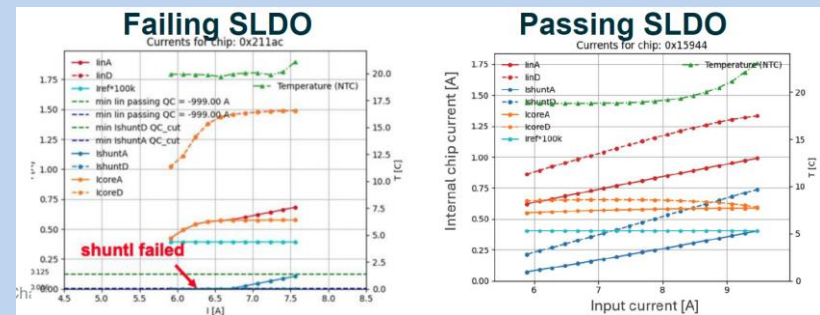
- Wafer probing does not identify any core columns, but should be sensitive to them
  - Electrical testing shows a range of symptoms that are not repeatable in successive tests
  - Strong correlation between sLDO failures and core column issues for vendor B
- This suggests mechanical damage may be the issue

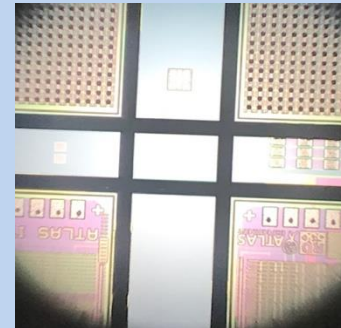
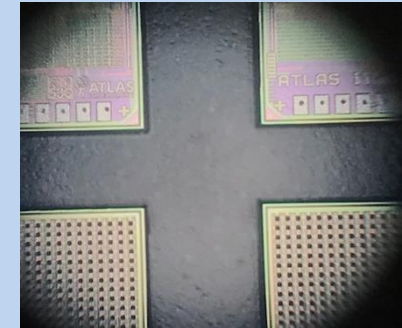
- Defective core columns appear to be caused mainly by debris across the surface. Aim to reduce debris on surface
- Current FE-wafer bump deposition vendor
  - Improved handling after dicing by replacing dicing tape
  - Rate of modules with defective core columns reduced from 39% → 20%
- Use the same FE-wafer bump deposition vendor and dicing vendor as vendor A
  - Rate of modules with defective core columns reduced from 39% → 20%
- Improvements have also significantly reduced the number of sLDO failures associated with core column issues
  - 72% → ~27%

Double dicing removes test structures but leaves Si dust

Replace dicing tape to remove shards and dust

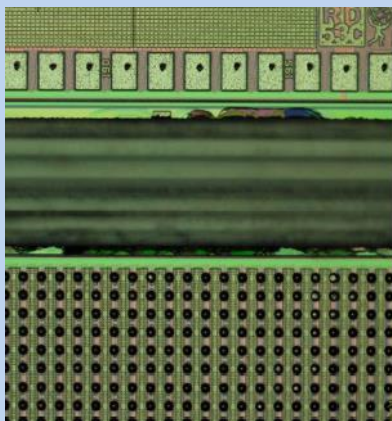
Saw dicing

- Defective core columns appear to be caused mainly by edge chipping
- Chipping on edges shows significant damage near the surface of the chip
  - Attributed to low-k dielectrics used in 65nm CMOS process being difficult to saw
- Can result in damage up to the seal ring or into the matrix and debris on the matrix

- Use laser pre-grooving to reduce damage at the edges when cutting low-k dielectric
- Initial studies show less chipping at edges
- Modules currently being assembled for electrical tests
